ADVANCED REFRACTORY ALLOY CORROSION LOOP PROGRAM

QUARTERLY PROGRESS REPORT NO. 14

For Quarter Ending October 15, 1968

**NUCLEAR SYSTEMS PROGRAMS
SPACE SYSTEMS
GENERAL   ELECTRIC
CINCINNATI, OHIO 45215**

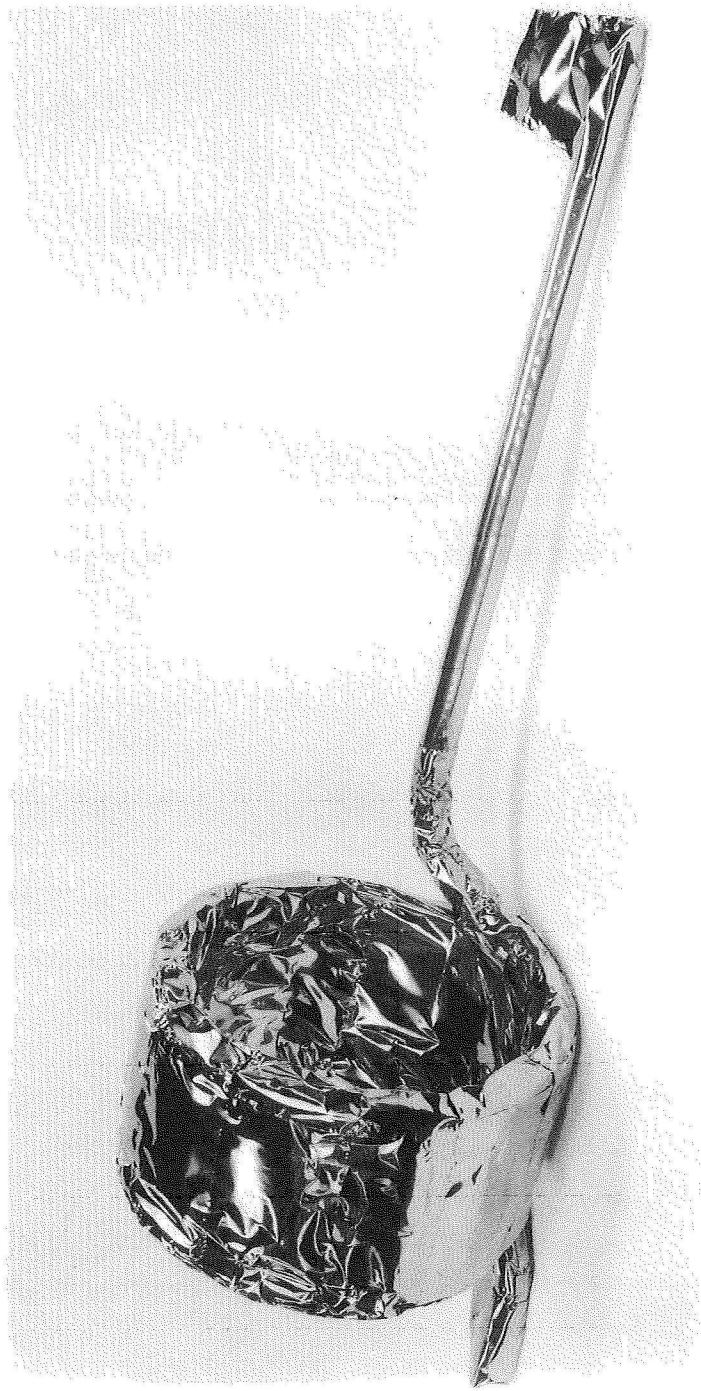
Figure 11. Repaired T-111 Corrosion Loop Boiler Wrapped with Cb-12r Foil
in Preparation for Postweld Annealing. (C68090903)

The repaired boiler was wrapped with Cb-1Zr foil as shown in Figure 11 in preparation for postweld annealing at Union Carbide Stellite Corporation, Kokomo, Indiana. A general description of the ABAR Model 90 furnace employed for this heat treatment is given in Table III. This chamber had been previously qualified on August 28, 1968 and the results of this qualification are given in Table IV.

The postweld anneal was performed successfully on September 10, 1968, according to NSP Specification 03-0037-00-A, "Postweld Vacuum Annealing of Cb-1Zr and T-111 Alloys." The chamber pressure was maintained below 1×10^{-5} torr at temperatures above 1000°F, and the maximum pressure with the boiler at 2400°F was only 5×10^{-6} torr. Analysis of T-111 coupons
